REED AREA NO. 3  
(COOT LAKE DAM)

PHASE I INSPECTION REPORT  
NATIONAL DAM SAFETY PROGRAM

BLACK & VEATCH  
CONSULTING ENGINEERS  
KANSAS CITY, MISSOURI

AUGUST 1978

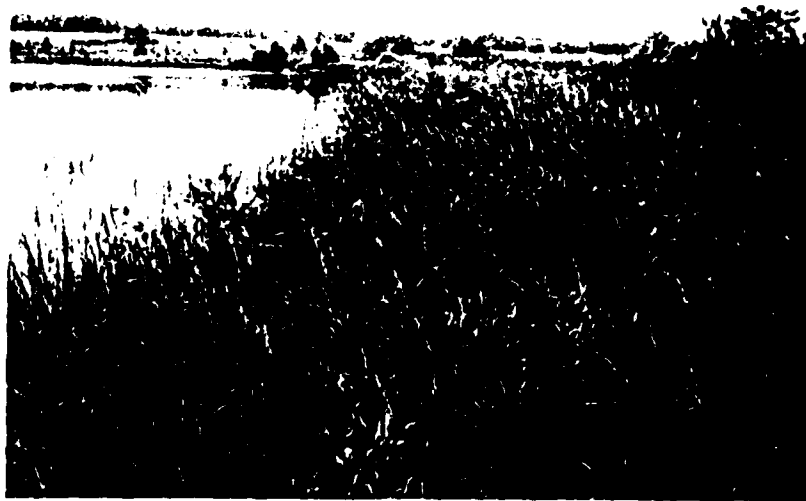
b. Dam. The inspection team observed the following items at the dam. No surface cracks or unusual movement of the embankment was found. There was no problem of sloughing or erosion of the embankment or abutment slopes. The riprap on the upstream face is small but no problem of erosion was sighted. There was no noticeable seepage in the embankment or at the toe of the dam. The lake level at the time of the inspection was four feet below normal pool elevation which is probably due to the prolonged period of drought preceding the inspection.

Photo 1: Upstream Face of Dam (Looking East)

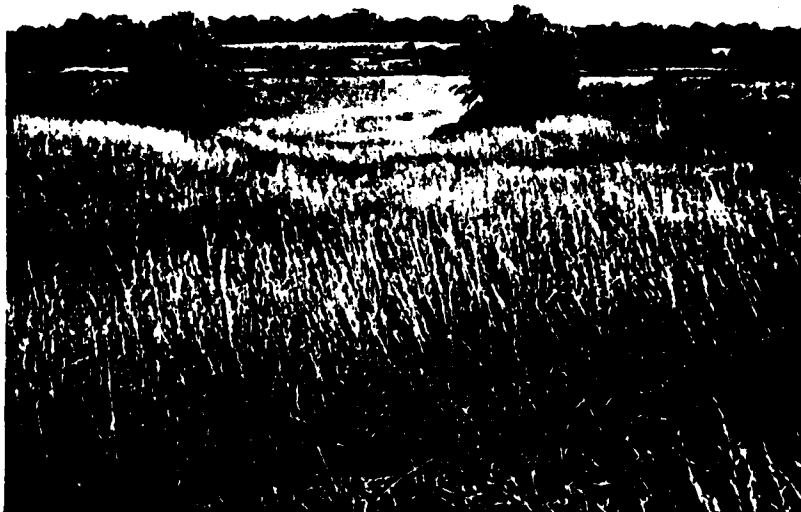
The emergency spillway channel was in good condition with no evidence of erosion of either the bottom or the side slopes of the channel. There was a good stand of grass in the channel to help prevent erosion.

(2) The emergency spillway channel is in good condition with no evidence of erosion at the time of the inspection.

Photo 7: Emergency Spillway Channel (Looking Upstream)
